P&WA CNLM-5208  
 QUARTERLY PROGRESS REPORT NO. 3  
 January 2, 1964 to March 31, 1964

INVESTIGATION OF CAVITATION DAMAGE OF MECHANICAL PUMP  
 IMPELLERS OPERATING IN LIQUID METAL SPACE POWER LOOPS

CONTRACT NAS3-2541

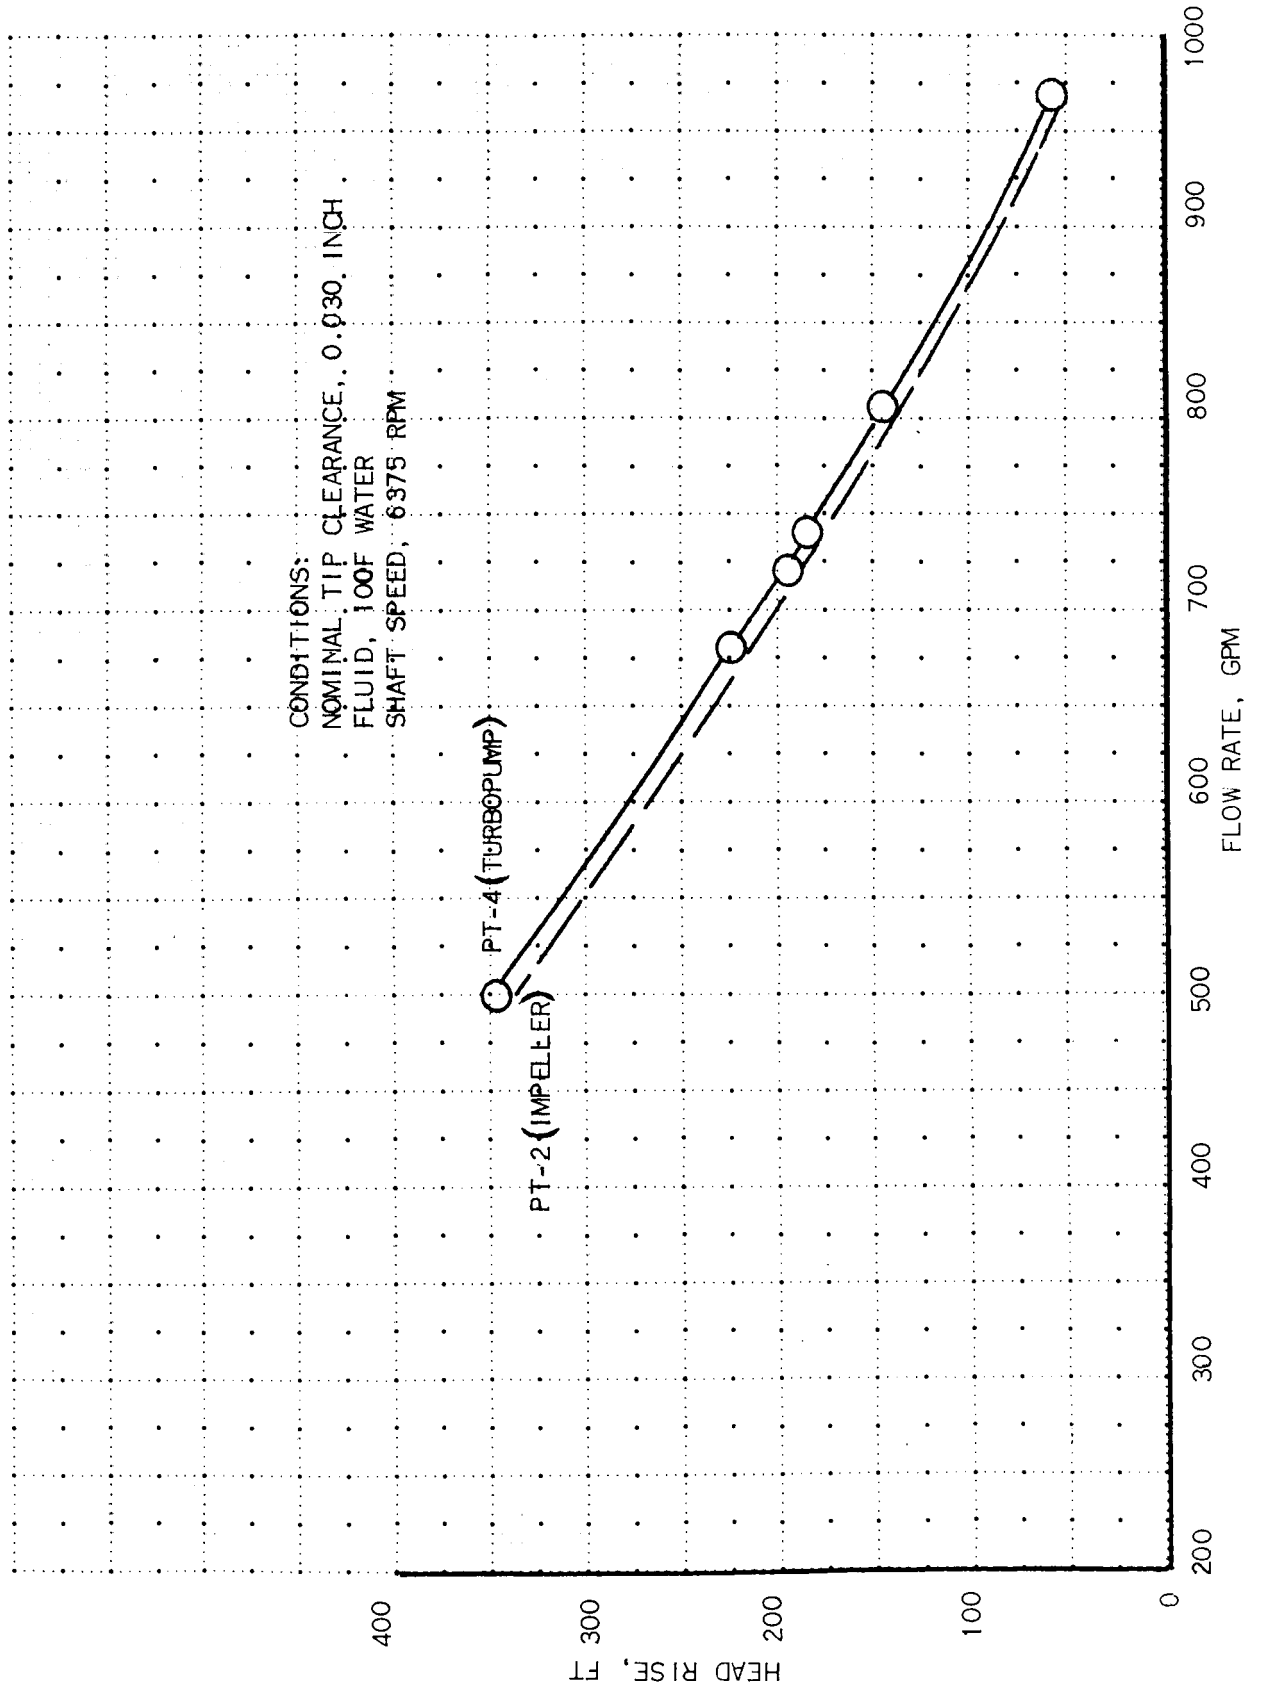
FIG 1

Hydraulic and cavitation testing of the TP-1 turbopump in the PT-4 test stand were completed during the quarter. The hydraulic performance data obtained are shown in Figure 1 as the solid line. The broken line indicates impeller performance during tests in the PT-2 stand and as reported in the previous quarterly. The increased performance of the turbopump is due to a reduced tip clearance on the impeller over that used in PT-2 tests. The reduced clearance (0.030 inch in PT-4 and 0.035 inch PT-2) was caused by the difficulty of obtaining accurate measurements of the end play of the pump shaft mounted on the deep-groove radial bearing. Since the shapes of the two head-flow curves of Figure 1 are nearly identical, it is inferred that the scroll losses are on the order of those for the vaneless diffuser used in the PT-2 impeller test stand.

## HEAD-FLOW FOR THE TP-1 TURBOPUMP WITH THE RI-7C3 IMPELLER

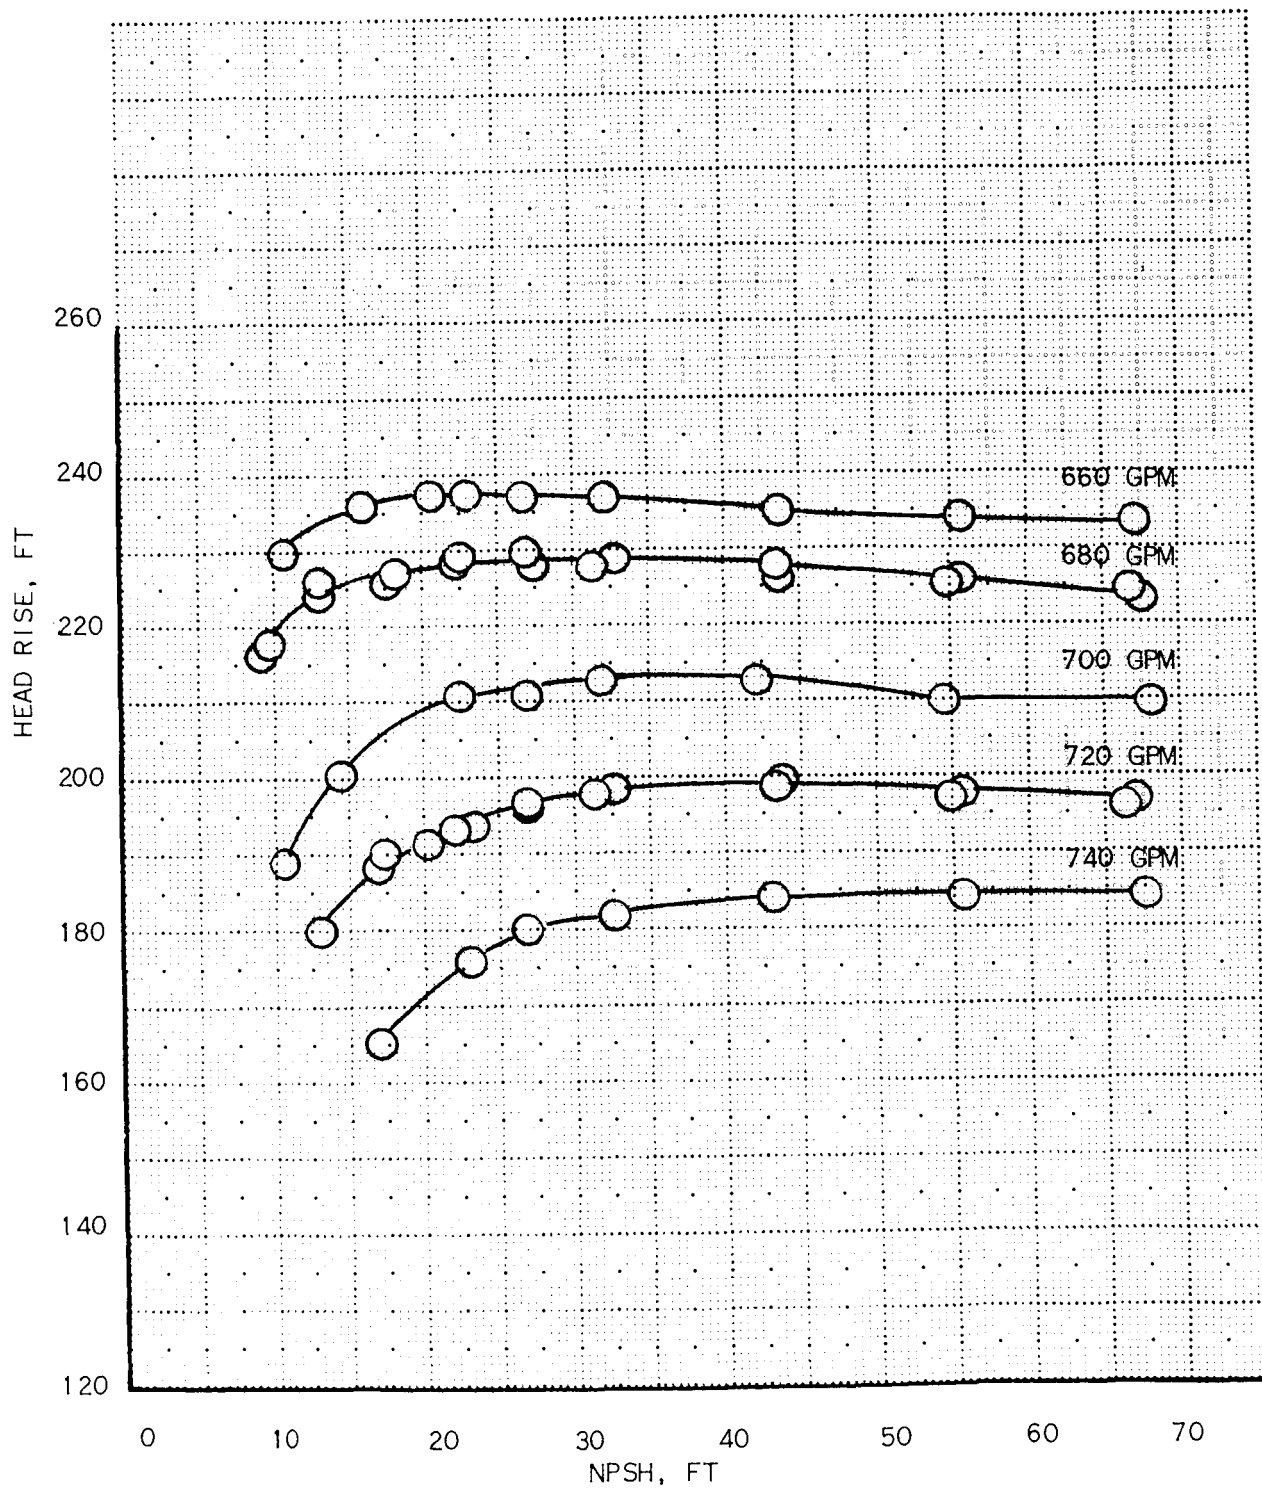
FIG 2

The cavitation performance is shown in Figure 2 for the five flowrates of interest. The performance of this pump is considered to be very good in all respects. The impeller-scroll adapter, which was subjected to considerable analysis, appears not to have adversely affected the performance. Scroll losses at low NPSH were very low for a flowrate of 660 gpm, increasing slightly as flow was increased to 740 gpm.

# CAVITATION PERFORMANCE OF THE TP-1 TURBOPUMP WITH THE RI-7C3 IMPELLER

CONDITIONS:  
NOMINAL TIP CLEARANCE, 0.030 INCH  
FLUID, 100F WATER  
SHAFT SPEED, 6375 RPM

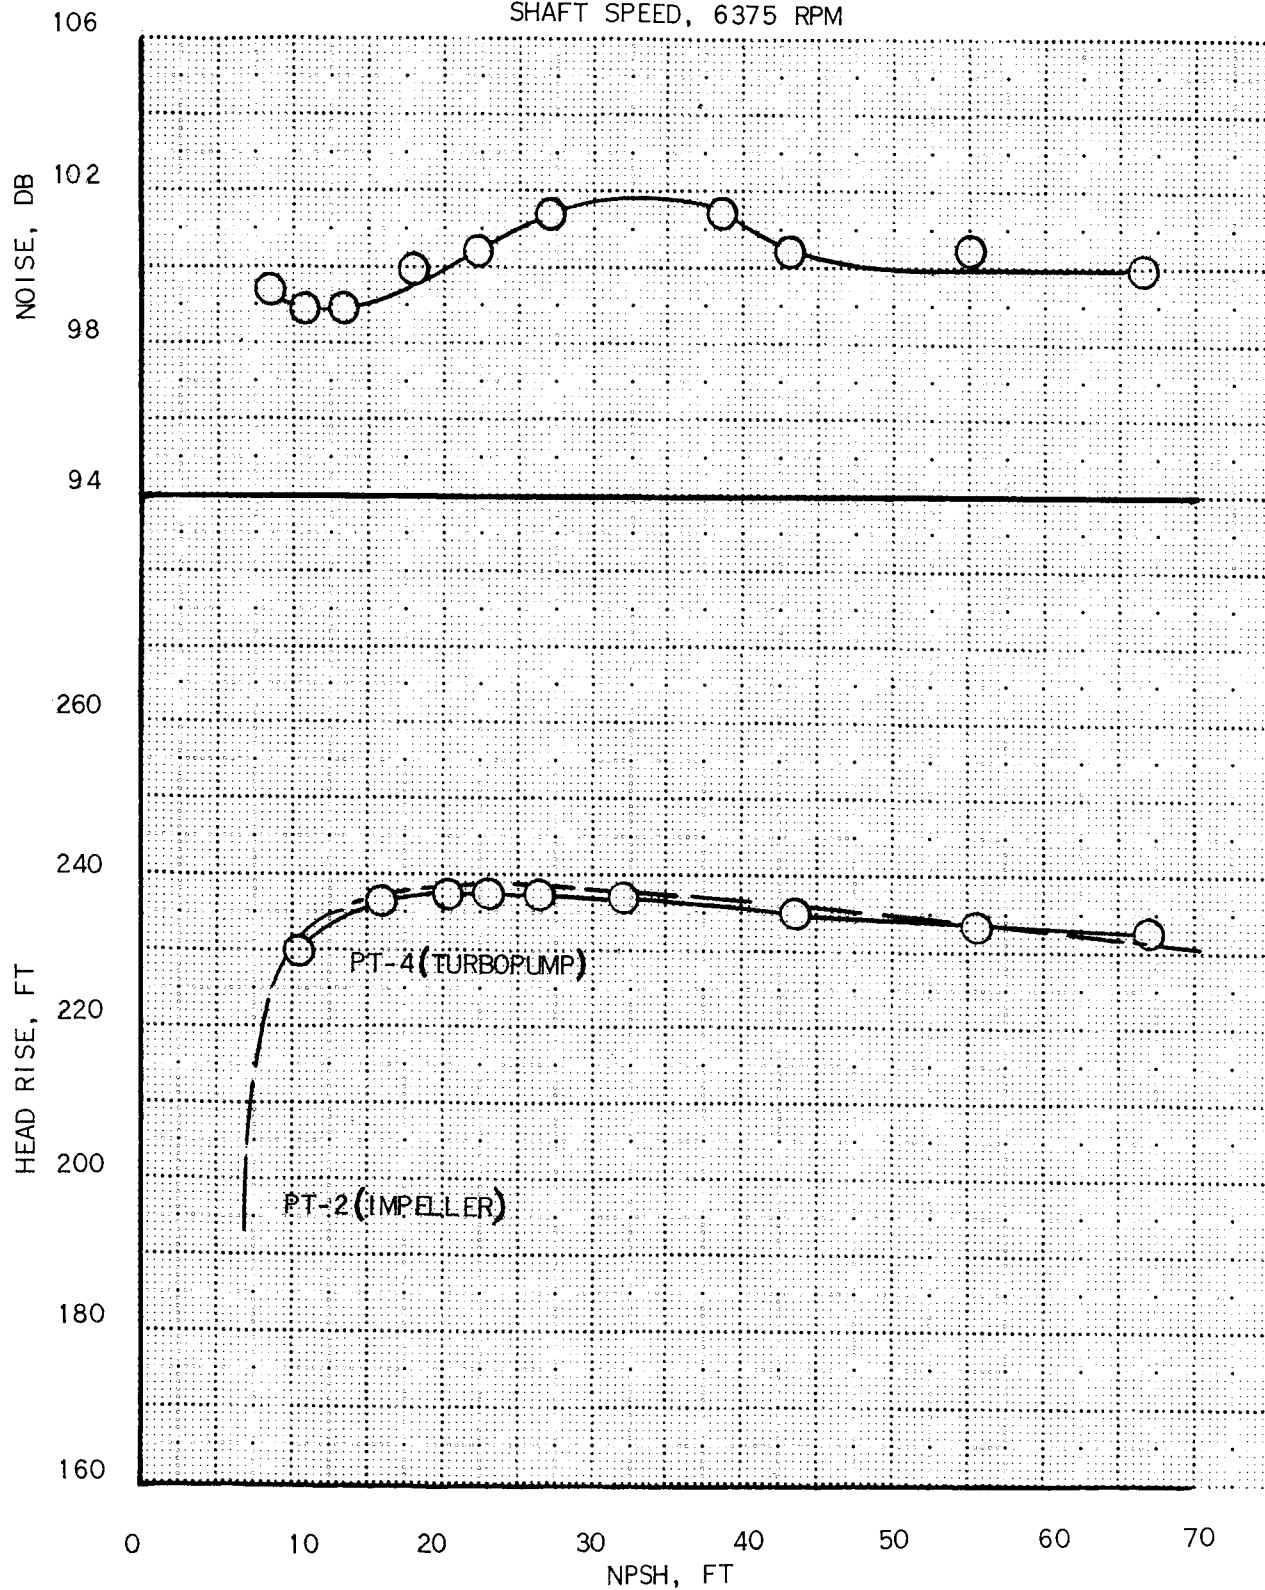
FIG 3

The cavitation performance of the TP-1 turbopump in PT-4 tests is compared to the performance of the impeller in the PT-2 tests in Figures 3, 4, and 5 for the three flowrates of 660, 700, and 740 gpm. Scroll effects in cavitation performance are evident in these curves. The 660-gpm flow performance in PT-4 tests is very close to that in PT-2 tests as shown in Figure 3. A decrease in head rise begins at higher NPSH for flows of 700 gpm (Figure 4) and 740 gpm (Figure 5) in the PT-4 tests.

# NOISE AND HEAD RISE VERSUS NPSH FOR THE TP-1 TURBOPUMP WITH THE RI-7C3 IMPELLER AT 660 GPM

CONDITIONS:  
FLUID, 100F WATER  
SHAFT SPEED, 6375 RPM

The sound intensity data are shown in Figures 3, 4, and 5 above the cavitation performance curves. The shape of these sound curves is similar to that obtained during the impeller tests in the PT-2 test stand. The sound curve for 700 gpm from PT-2 tests is plotted in Figure 4 as a broken line for comparison. It is apparent from this comparison that the background sound intensity from the turbopump water test was considerably greater than for the impeller test.

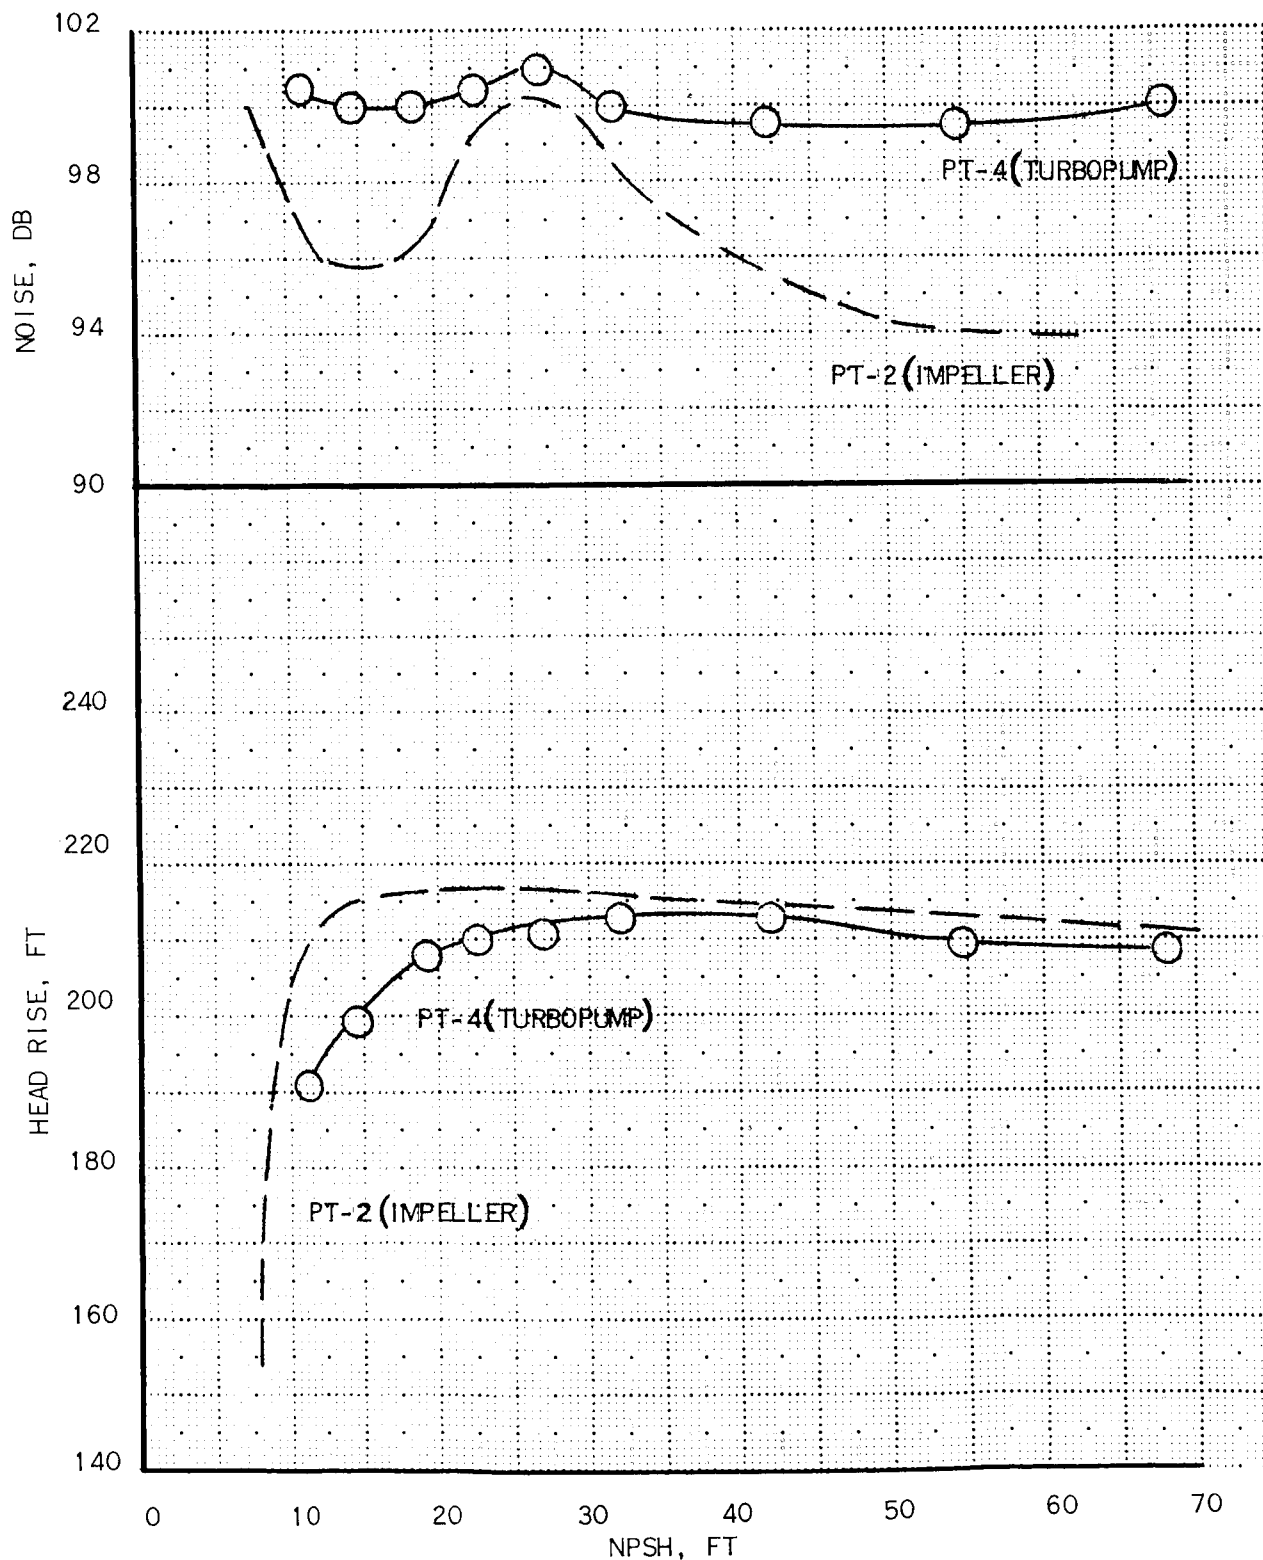
FIG 4

# NOISE AND HEAD RISE VERSUS NPSH FOR THE TP-1 TURBOPUMP WITH THE RI-7C3 IMPELLER AT 700 GPM

CONDITIONS:

FLUID, 100F WATER

SHAFT SPEED, 6375 RPM

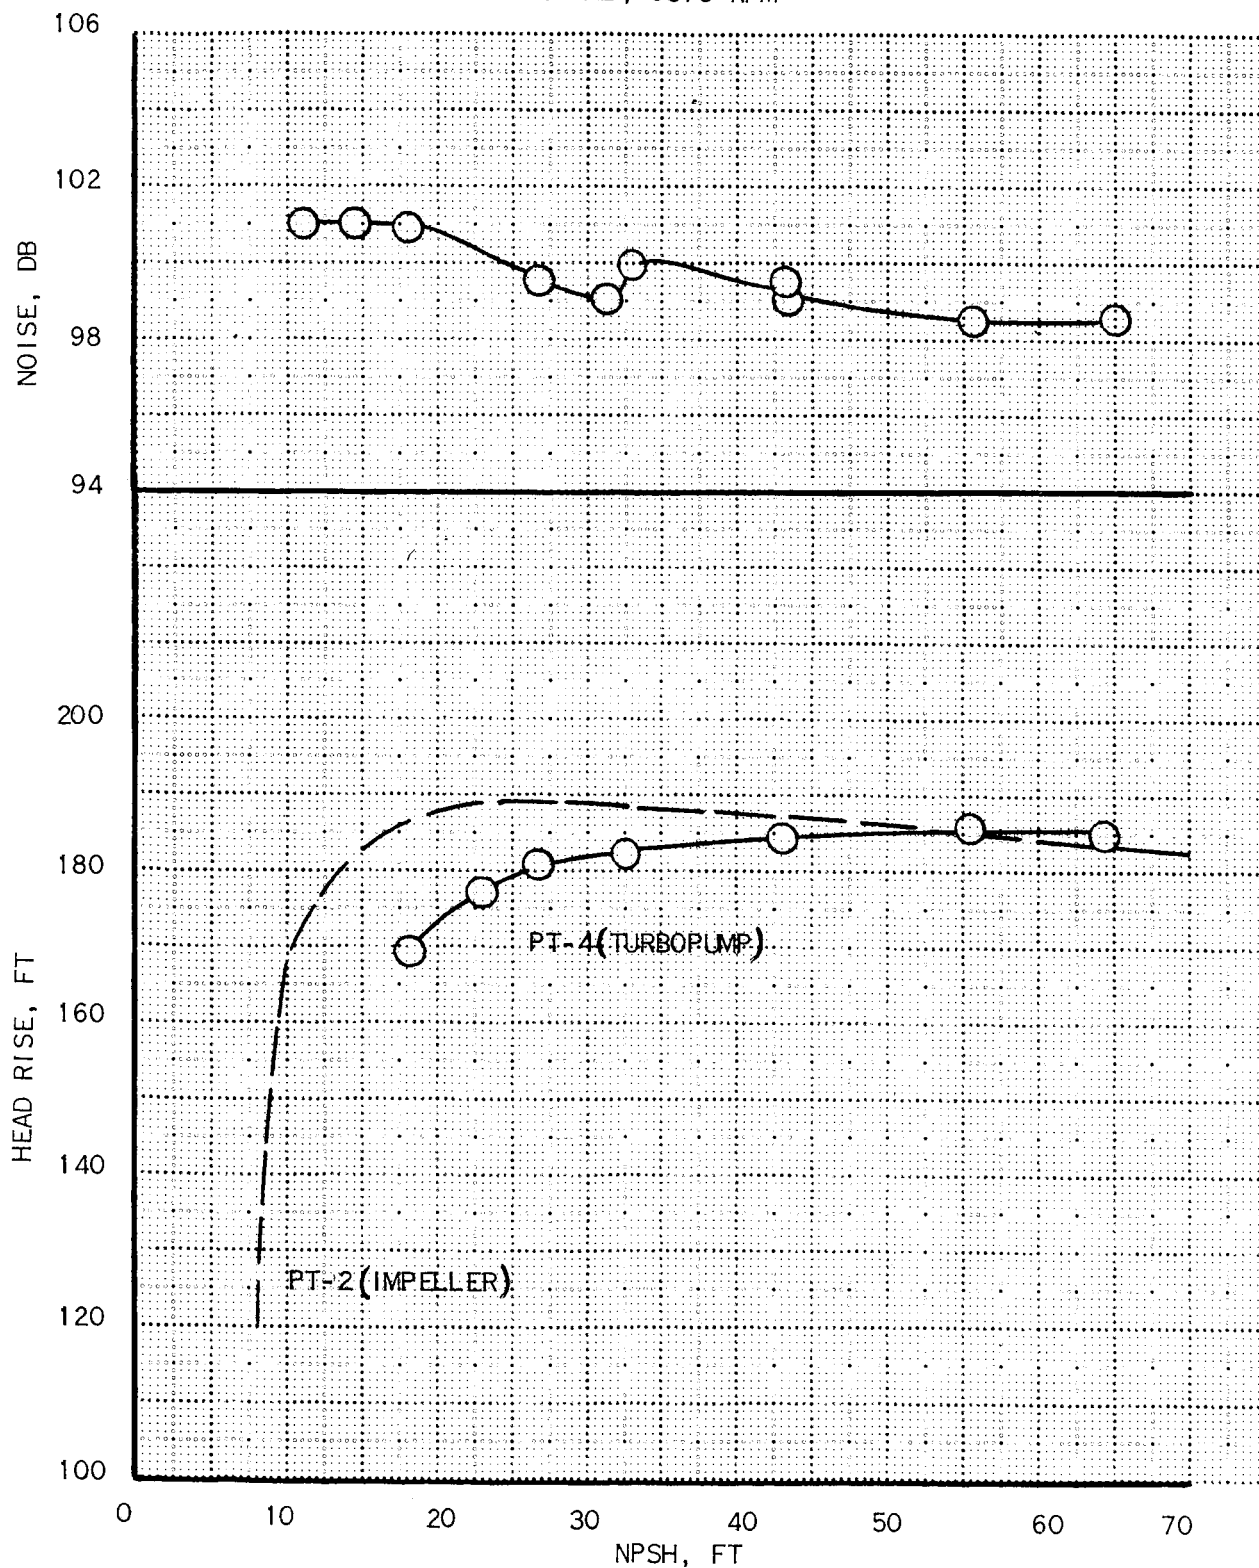
FIG 5

# NOISE AND HEAD RISE VERSUS NPSH FOR THE TP-1 TURBOPUMP WITH THE RI-7C3 IMPELLER AT 740 GPM

CONDITIONS:  
FLUID, 100F WATER  
SHAFT SPEED, 6375 RPM

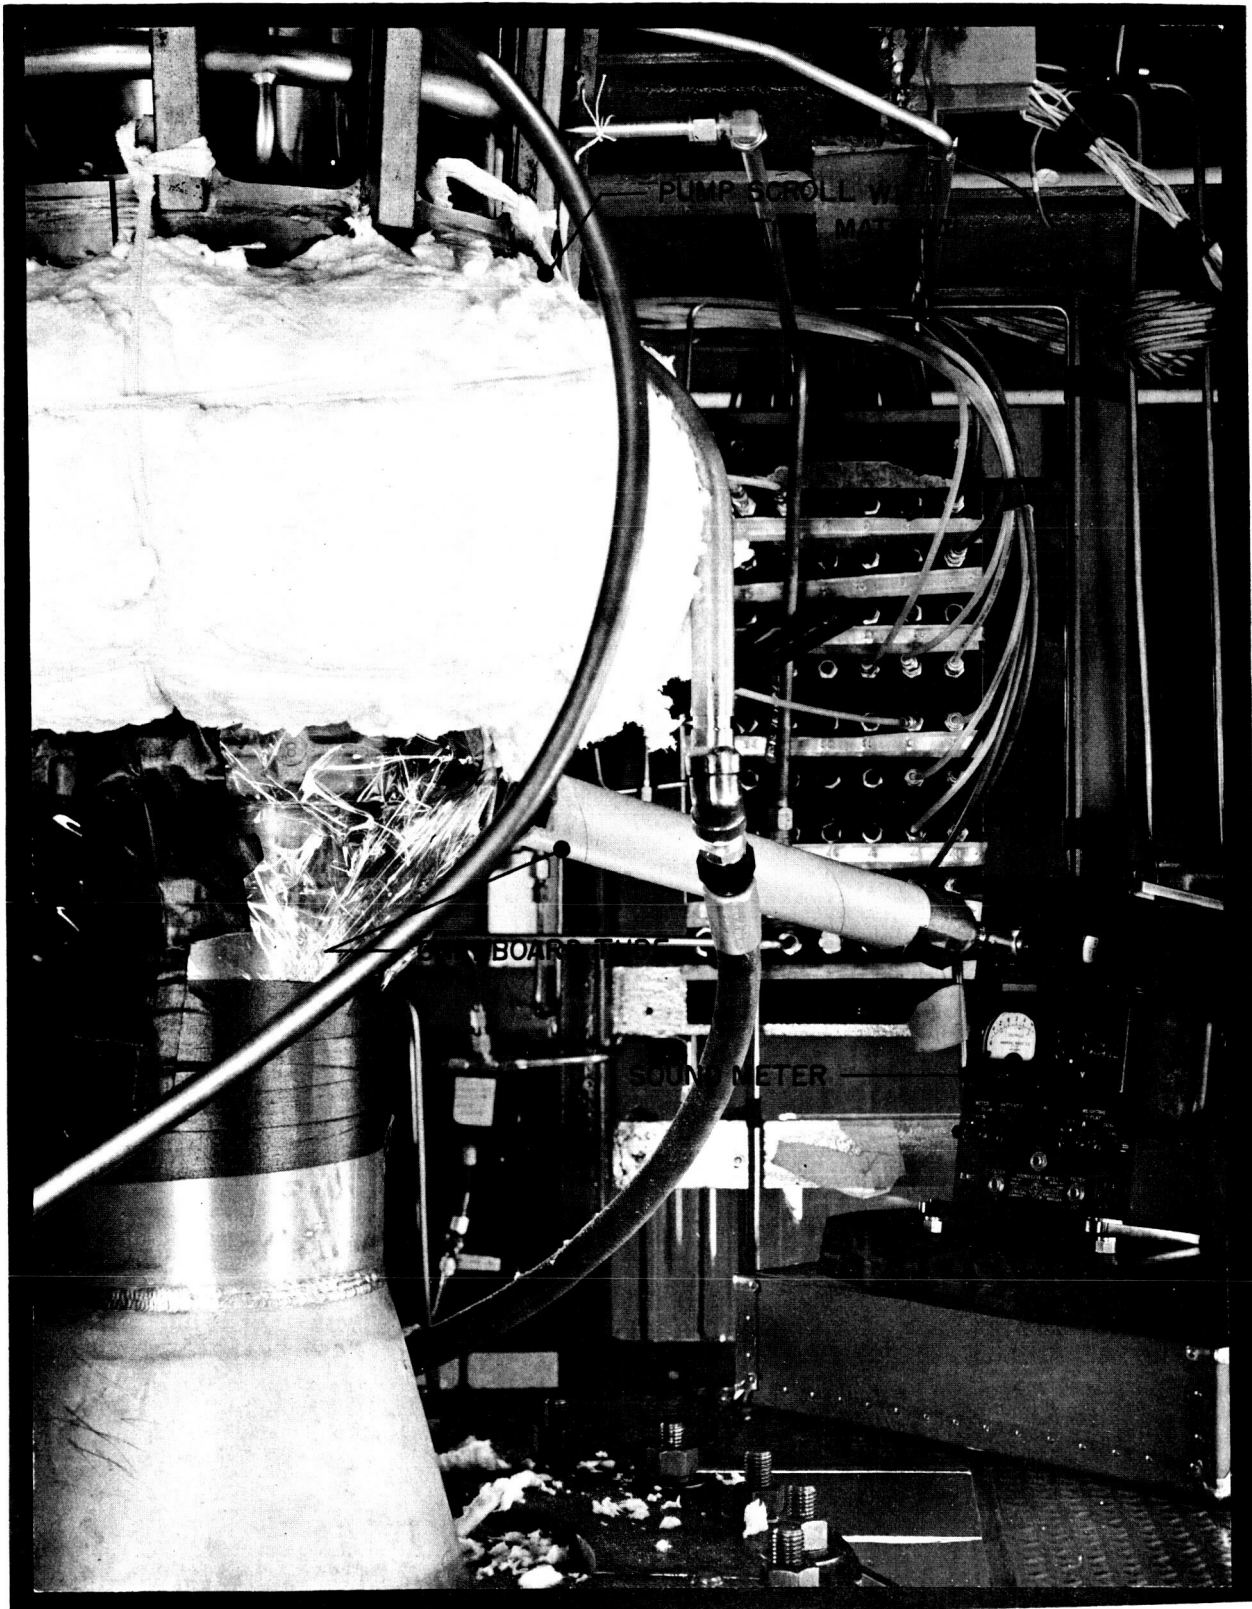
FIG 6

The general sound level in the PT-4 test stand was higher than for the PT-2 tests as a result of the turbine operation. Sound intensity data similar to the PT-2 tests was finally obtained by wrapping the turbine scroll and pump scroll with a sound-absorbing thermal insulation. The sound level meter was fitted with a cardboard tube over the microphone which was directed at the inlet pipe immediately below the pump scroll. This position provided the shortest sound transmission path through water and steel. The cardboard tube acted as a sound wave director to the microphone. The complete setup for obtaining sound data is shown in Figure 6. This same arrangement will be used in the liquid metal tests of PT-6 with a copper tube wrapped with a sound-absorbing insulation replacing the cardboard tube.

## SETUP FOR SOUND READINGS IN PT-4 TEST STAND

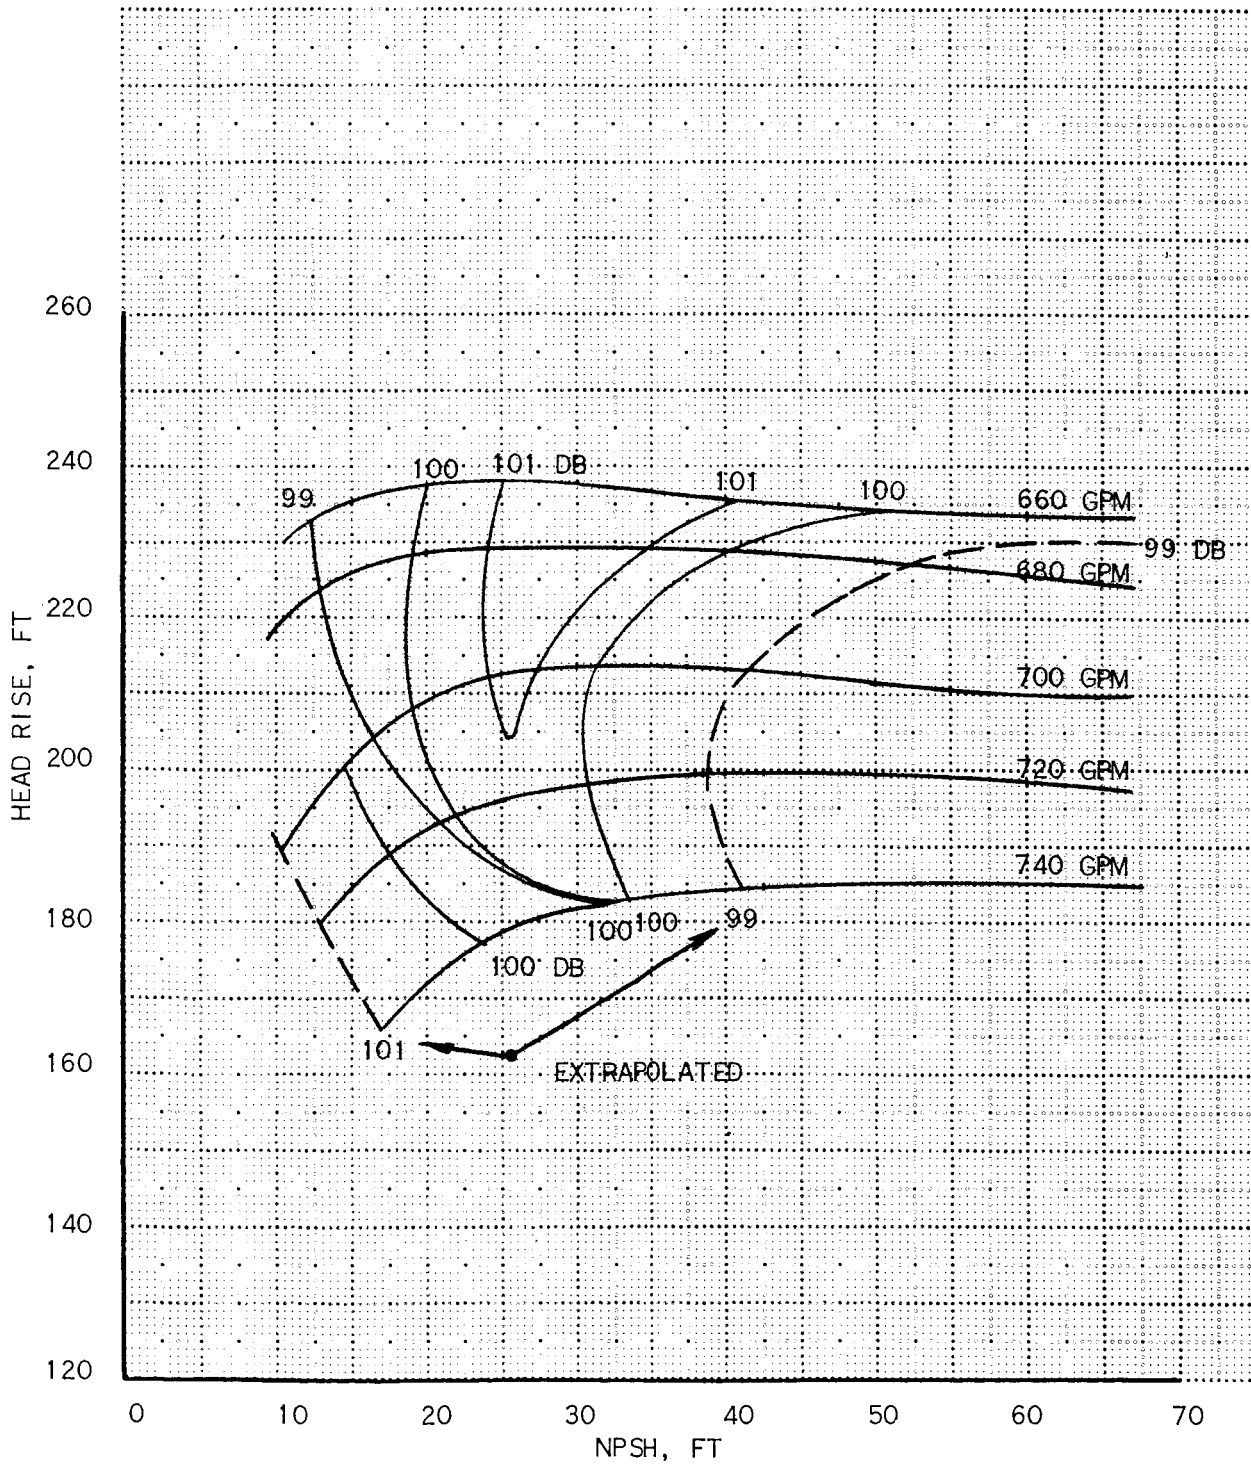
FIG 7

Figure 7 is a cross-plot of the sound intensity data showing the topographical pattern of sound generated over the five flowrates.

# CROSS PLOT OF NOISE AND CAVITATION PERFORMANCE FOR THE TP-1 TURBOPUMP

CONDITIONS:  
NOMINAL TIP CLEARANCE, 0.030 INCH  
FLUID, 100F WATER  
SHAFT SPEED, 6375 RPM

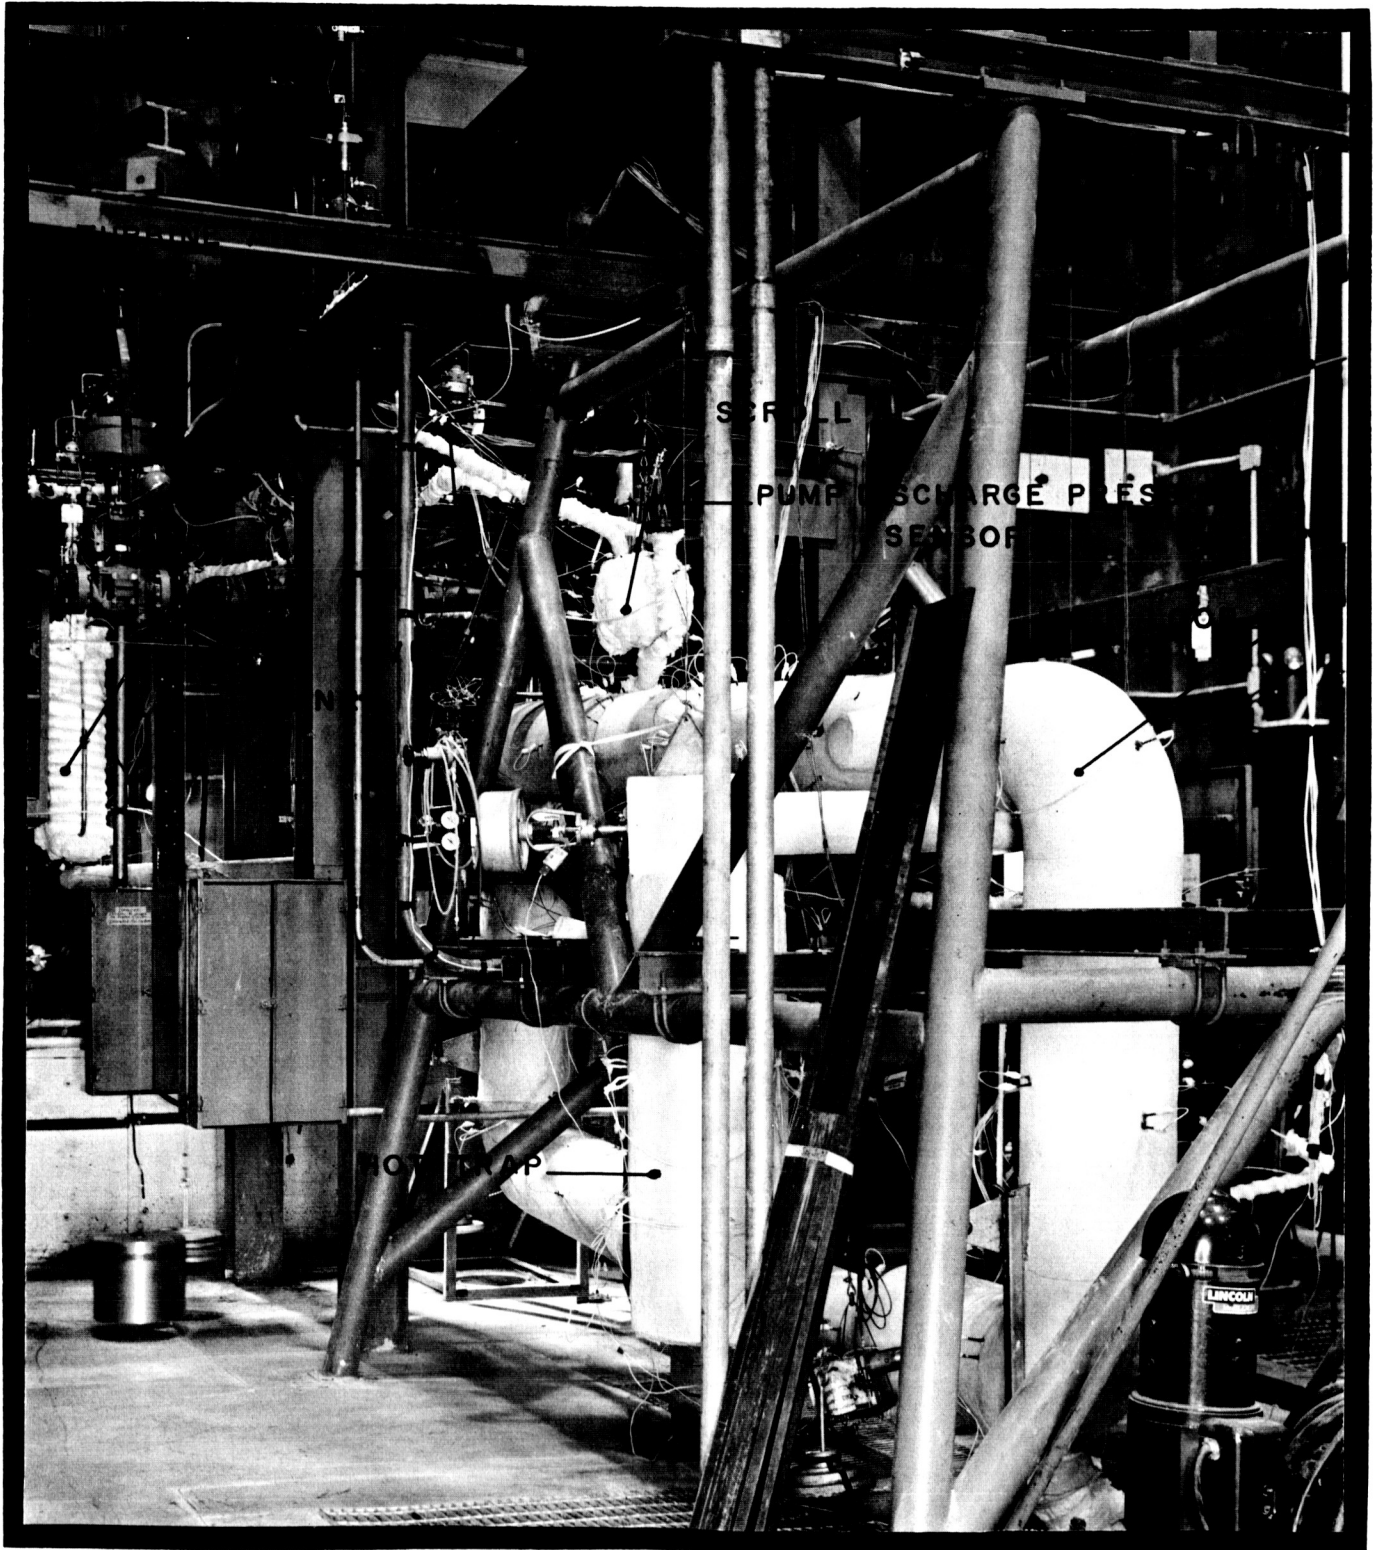
FIG 12

The liquid metal test stand (PT-6) construction was completed this quarter. A photograph showing the completed stand is given in Figure 12. A closeup view of the installed pump is presented in Figure 13. Preliminary cleanup operations are in progress. These include evacuation of the test loop and back-filling with argon gas, heating of the loop, and purging with purified argon to remove water vapor and residual oxygen. Purification of the potassium has been completed. Final oxygen level was obtained by the mercury amalgam method with three samples having readings of 16, 16, and 18 ppm.

## LIQUID METAL TEST STAND. PT-6

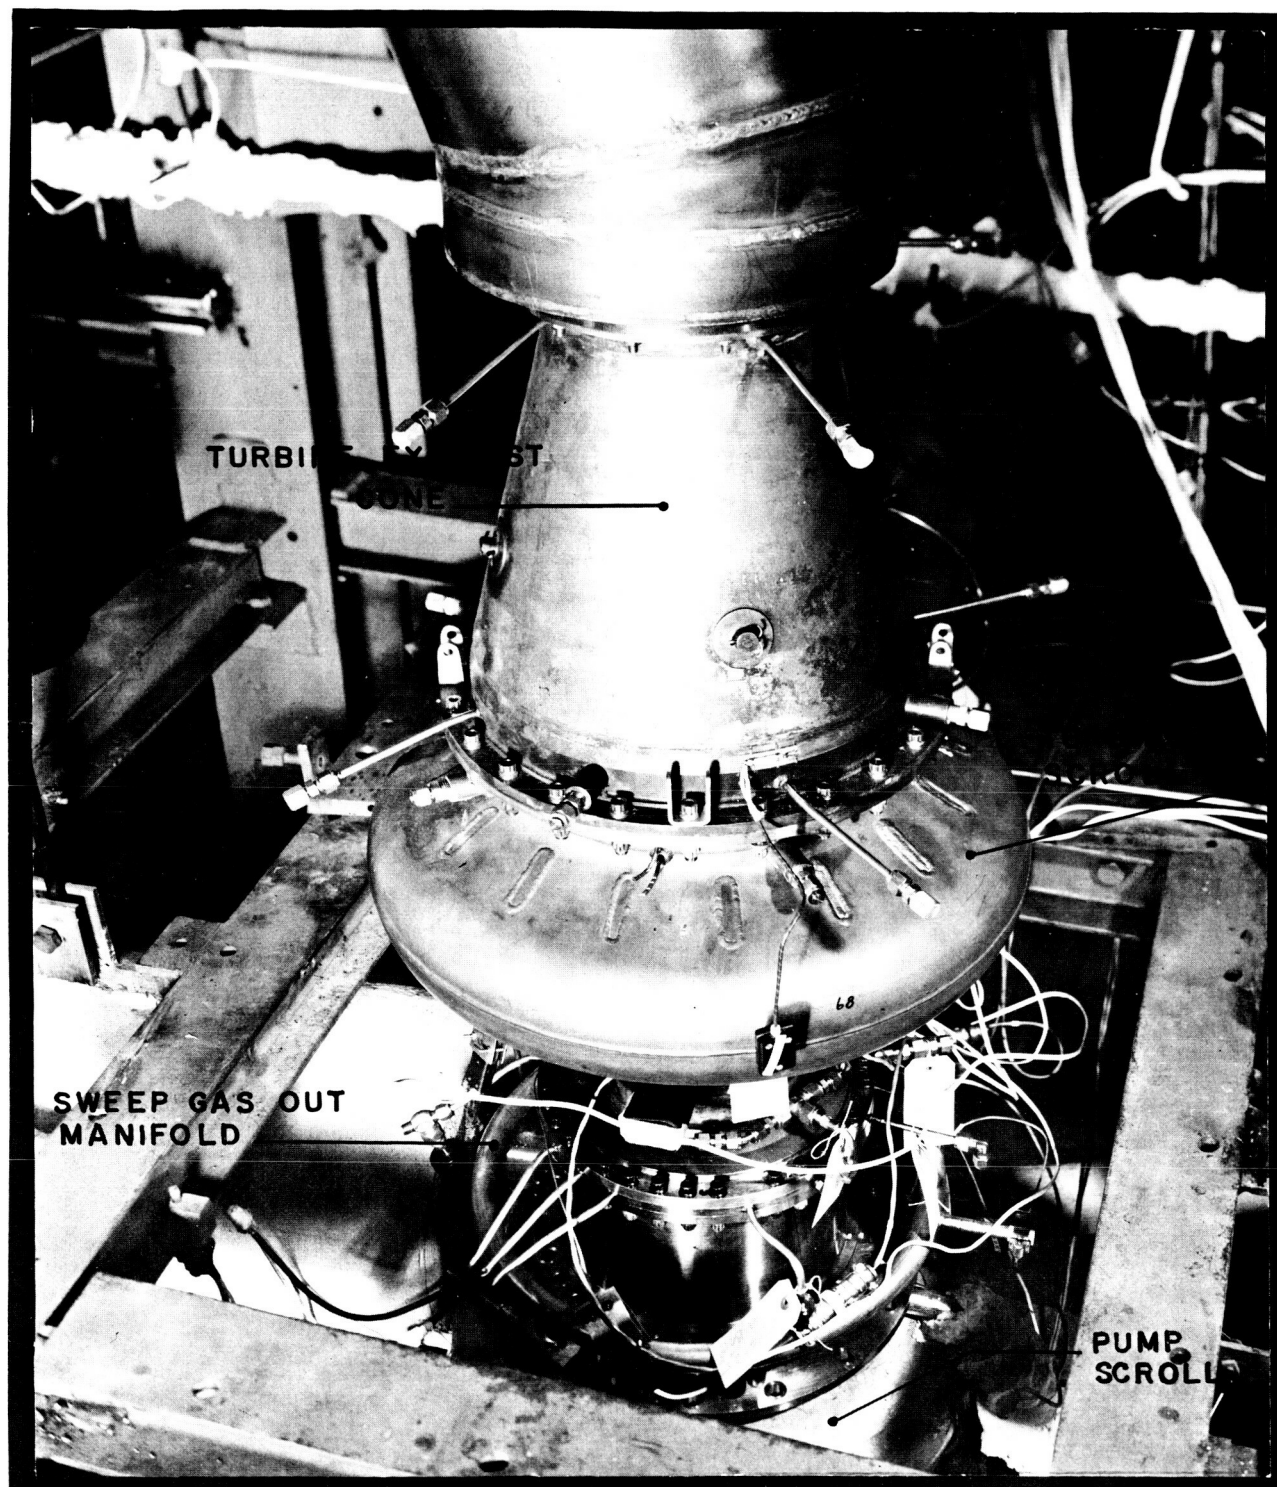
FIG 13

## TP-1 TURBOPUMP PARTIALLY INSTALLED IN PT-6 TEST STAND
